Partridge Creek Watershed

Landowners along steep slopes: Guide to the Watershed Plan

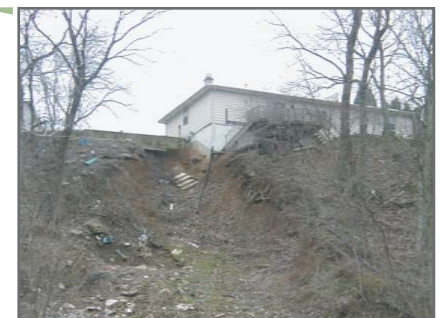
Development such as this in nearby Farm Creek Watershed can be problematic if erosion of slopes is not taken into account.

- Today's **thick canopy, dark forests** are a degraded version of the open canopy woodlands and savannas that once existed. This change in the forest has accelerated ravine erosion and depleted habitat value.
- Soils on steep slopes are highly erodible and many **houses built adjacent to steep slopes** are threatened by eroding ravines.
- **Development on the bluffs** increases stormwater flows that causes gully and ravine erosion. Soil lost in the bluffs is deposited in Partridge Creek and the Illinois River at Peoria Lakes.

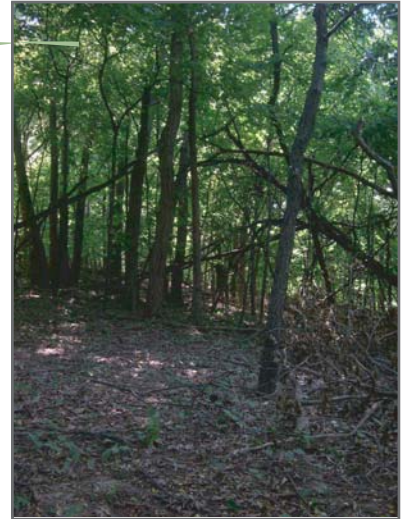
The photo above depicts an area without forest management. Invasive species have taken over, creating a dark, closed canopy that cannot support underlying vegetation.

- Manage forested areas to open the canopy and allow the growth of ground cover necessary for slope stability. Cut or girdle 80% of undesired tree species (i.e. sugar maples) that are under 8 inches diameter at breast height. Completely remove all non-native invasive plant species such as autumn olive, honey suckle, multiflora rose, and garlic mustard.

- Maintain open forests by removing undesirable saplings by pulling or conducting professional prescription burns about every three years. Areas that are not maintained generally return to "pre-management" conditions by year five.

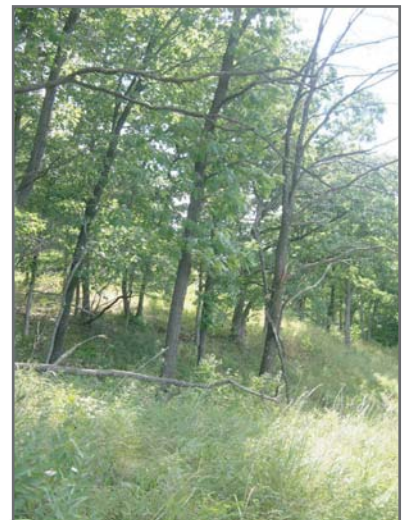
Forest management, as depicted in the photo above, opens up the canopy and allows for the growth of groundcover that is necessary for slope stability.

- Case studies in Peoria Park District bluffs have indicated that no seeding is necessary to grow grasses and flowering plants on virgin soils. Even after 80 years seeds and root systems are still viable and ready to grow! Fill material will need seeding.
